## Church of Scotland, Strontian

### Condition of Building

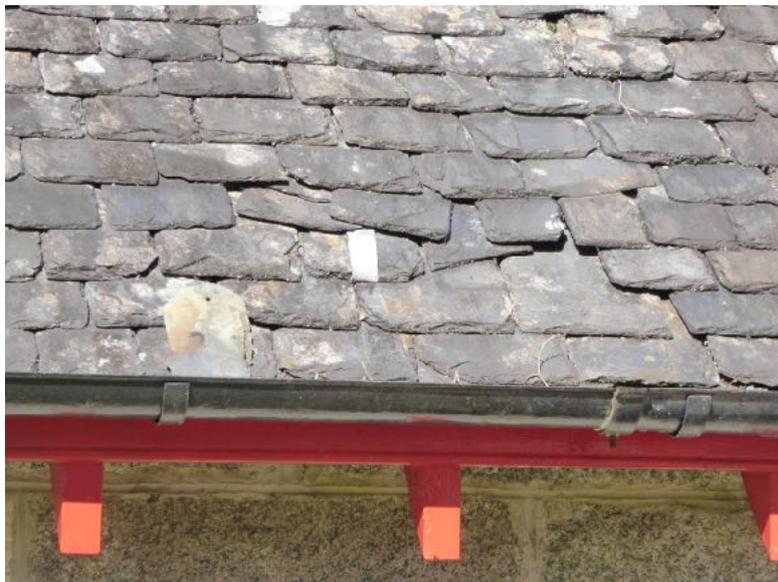
The slates are small in size and have probably been re-dressed in the past. As a result the head lap appears to be short and the roof is vulnerable to water ingress due to driving rain. In addition the slates are uneven and there are a number of slipped or missing slates. In the north-east corner there is an area of severely damage roofing with a number of missing slates.

*Defective slating at porch*

The roof requires re-slating which would also be an opportunity to install a breathable underslating membrane, and renew flashings as necessary. Ballachulish slates are difficult to source, and it is likely that re-slating would be in Spanish slates.

Reslate including vapour permeable roofing membrane, sarking repairs, roof ventilation flashings

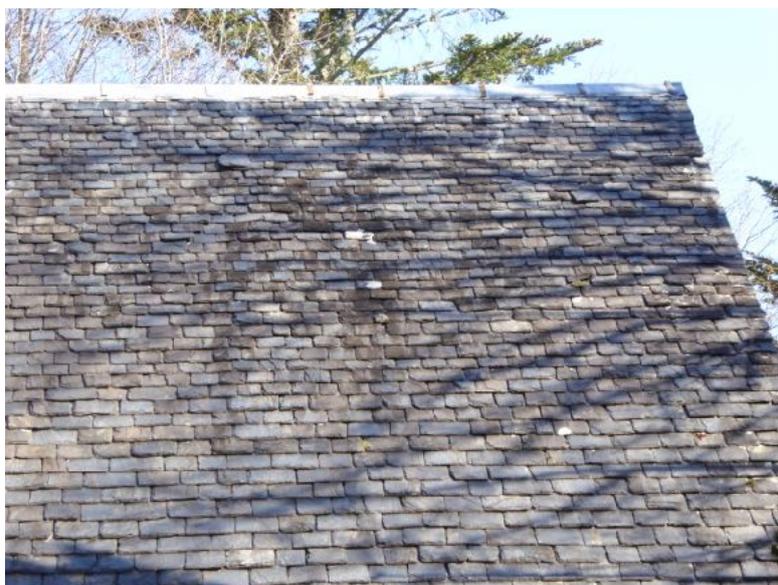
Slating to main roof

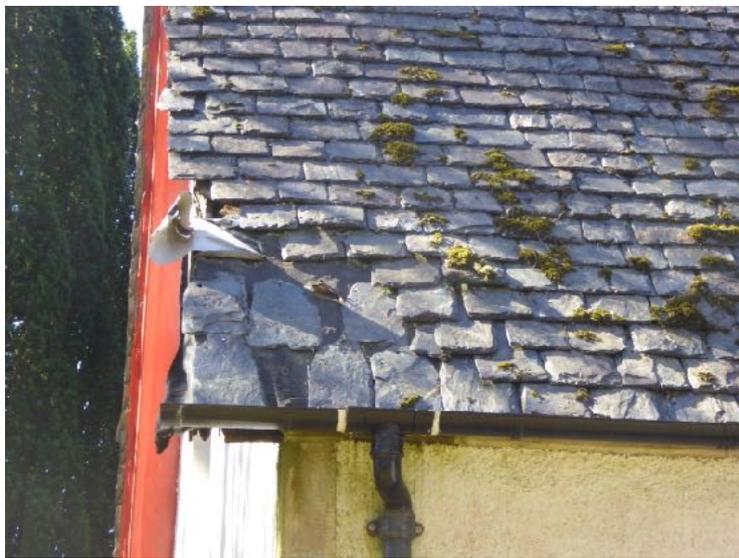
*North east corner*

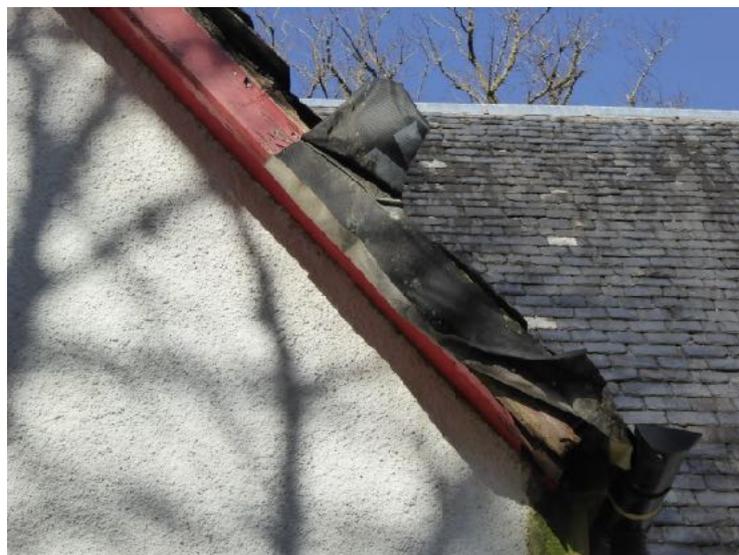
*Verge at east gable*

Repair external timber verge boards

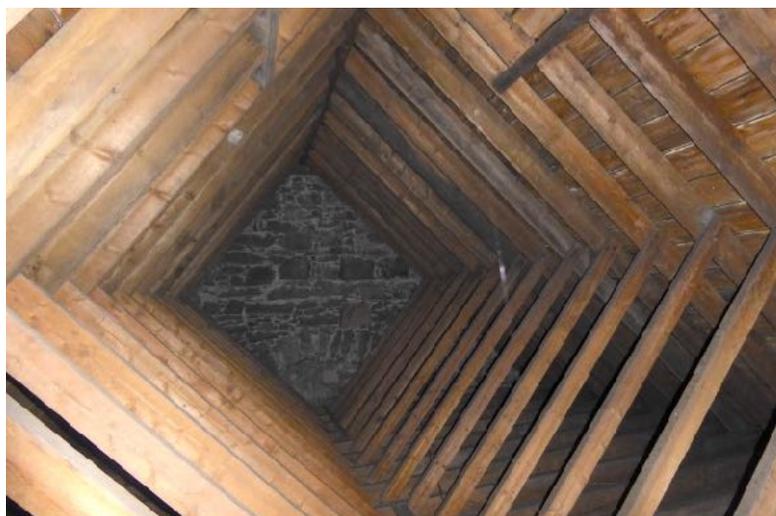
The roof structure comprises collar trusses of 60 x 160mm rafters and ties supporting timber sarking boards. The sarking is damp in patches suggesting widespread periodic water penetration.

There is minor woodworm infestation.

The roof space has no insulation. It has limited provision for ventilation.

Woodworm treatment

Insulate roof

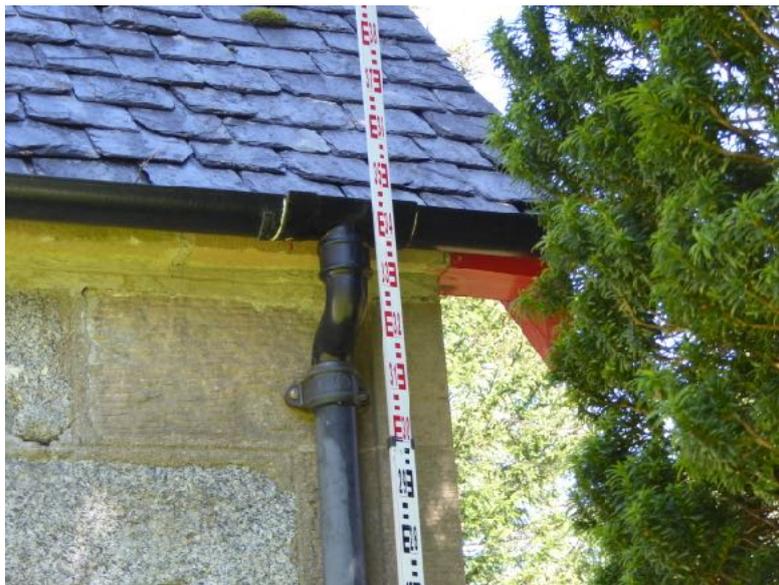
Gutters and downpipes are cast iron generally in moderate condition. There is a tendency for the gutters to block with leaves from the many surrounding trees and they require re-painting and minor making good.

*Cast iron gutters*

Repair rainwater goods and discharge to soakaway

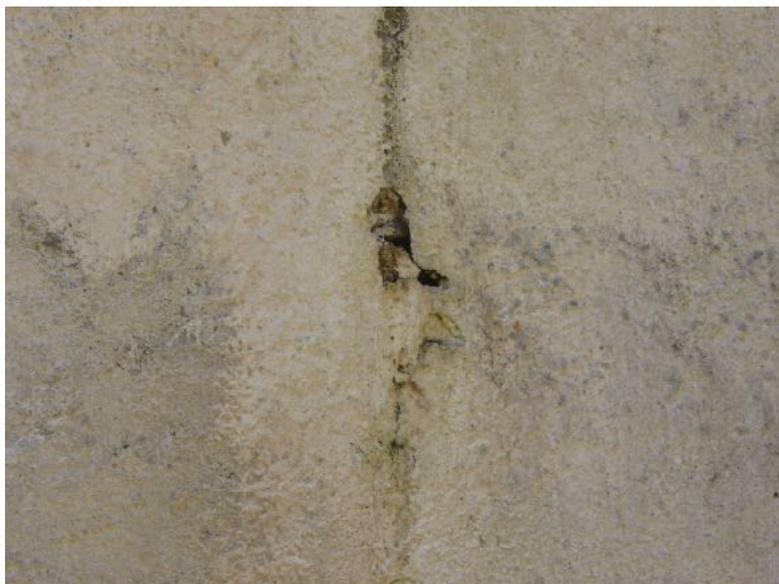
The walls are of masonry construction comprising granite blocks with sandstone dressings. The stonework is exposed on the south and west elevations and has render finishes on the north and east sides. There is minor cracking to pointing on the west side of the porch, and defective render on the north side of the main church and at low level in various locations. There is no evidence of a damp proof course in the walls.

*Defective render north elevation*

Render repairs and repair cracks generally

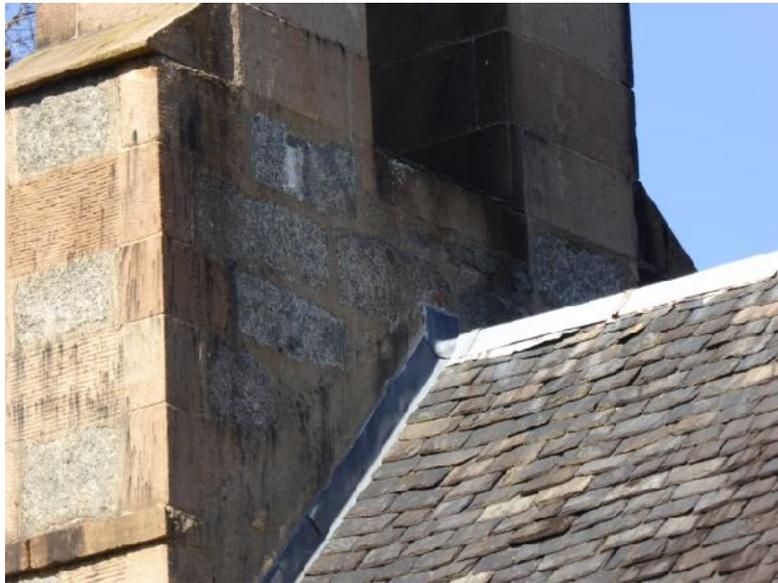
The west end of the church has a bellcote constructed in dressed sandstone. It was noted that the gable wall internally, shows significant damp staining and high moisture meter readings. There is a lead cover piece at the bell opening and damp staining below the chamfered stone blocks on either side.

*Leadwork at bellcote*

All flashings and pointing should be checked here and and new lead flashing over exposed stonework considered.

Bellcote repairs to flashings

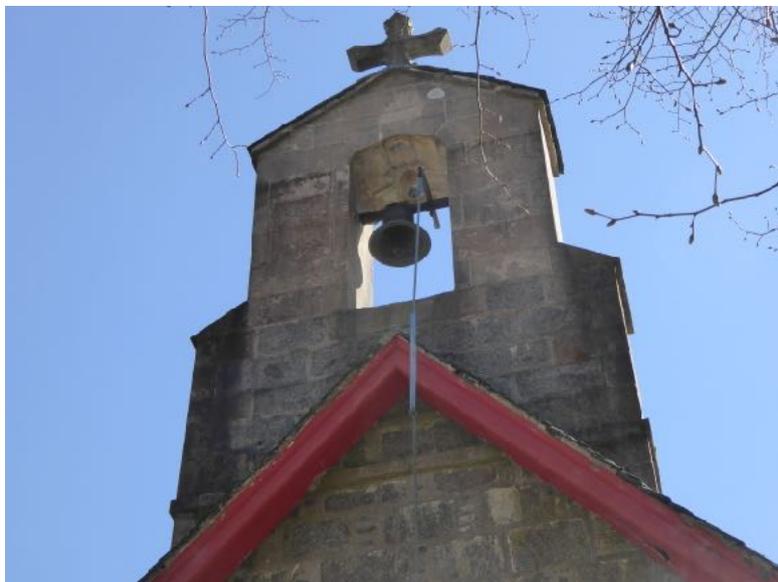
*Bellcote*

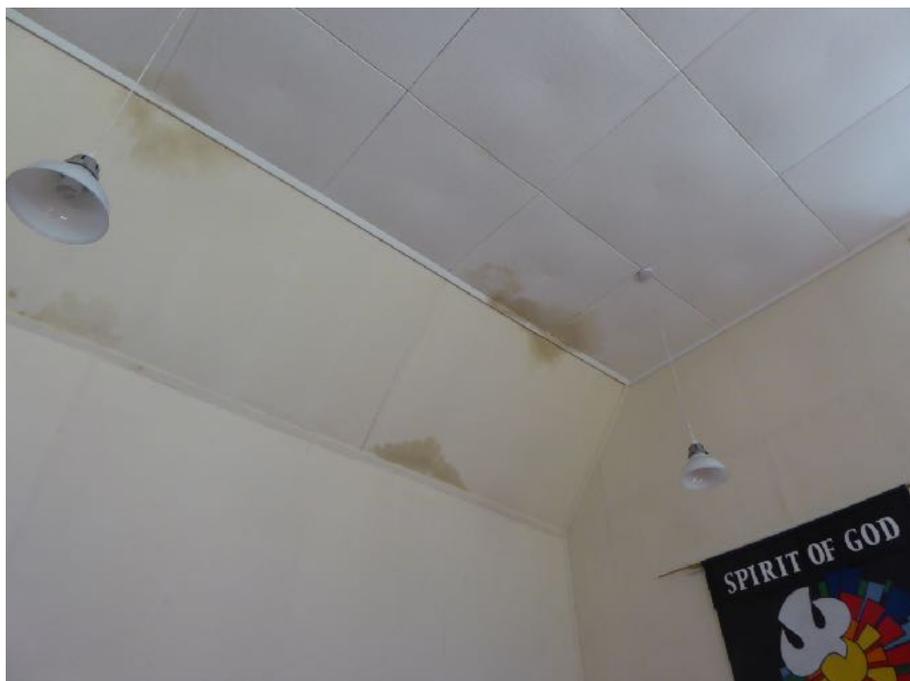
The main church space is lined with a plywood dado and fibreboard lining above, and to ceilings. This shows evidence of damp staining. Any combustible linings should be treated with fire retardant paint finishes.

*Damp staining on ceiling*

Reline internally including new framing and insulation to walls

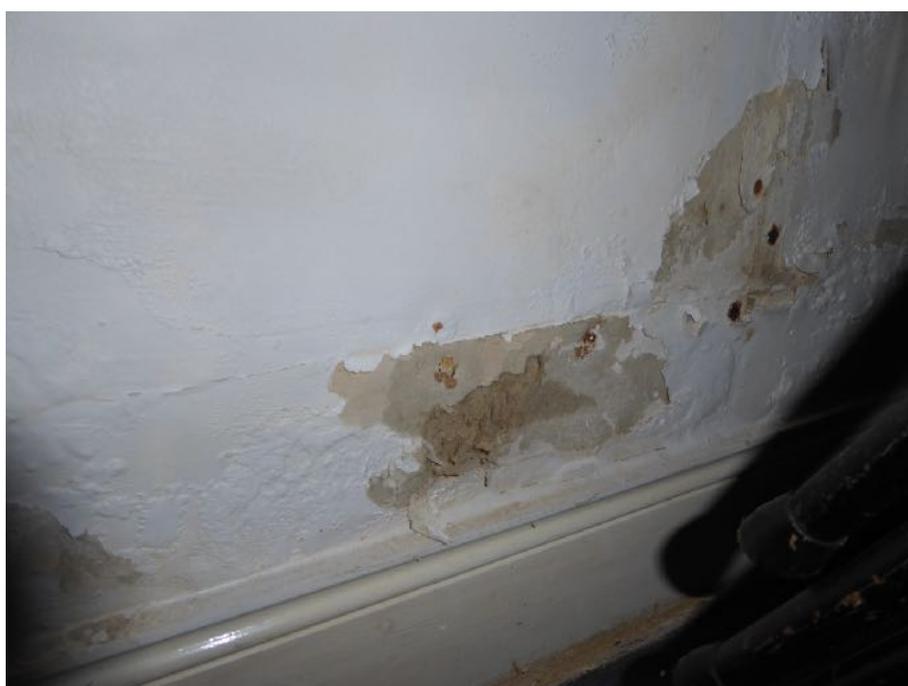
The vestry has timber 'V' lining with fibreboard above, again showing signs of damp. The kitchen and w.c. also shows damp stained and damaged linings. The meeting room has a lowered ceiling with a roof-light to admit light from the high level window. The gable wall here shows significant damp ingress as noted above. Condition of lintels was not inspected.

*Damp marking on west gable*

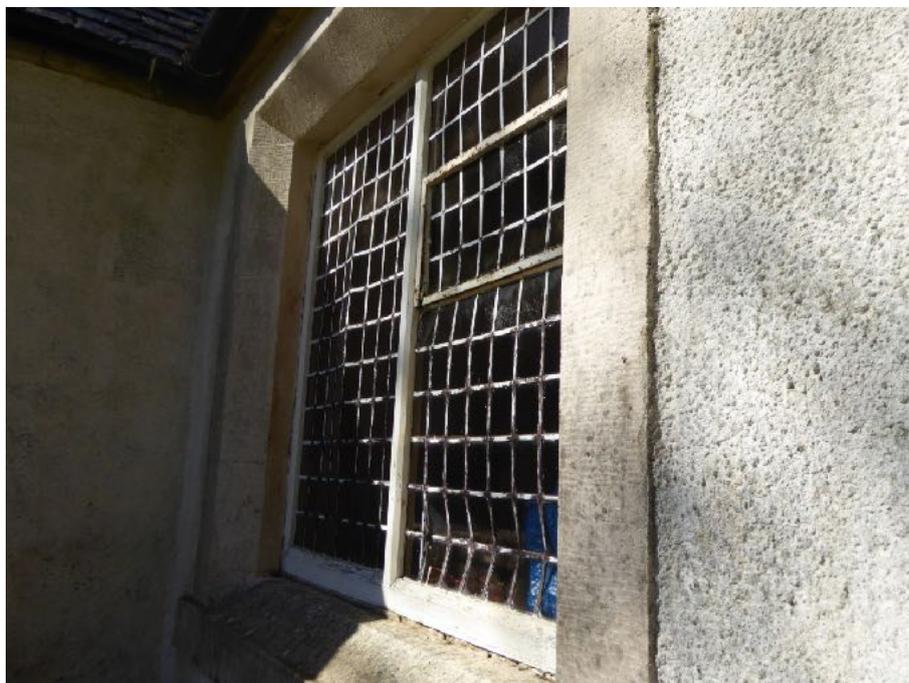
The windows to the vestry and kitchen are timber framed with small leaded lights. The lead comes are buckled and the opening hopper rusted. Stone cills are vulnerable to water ingress. The main door at the entrance porch and rear door to the vestry are of painted timber boarding. These are in moderate condition though show some signs of wear.

*Damage to window at vestry*

It would be reasonable to assume all windows would be replaced as part of any major refurbishment.

Replace windows

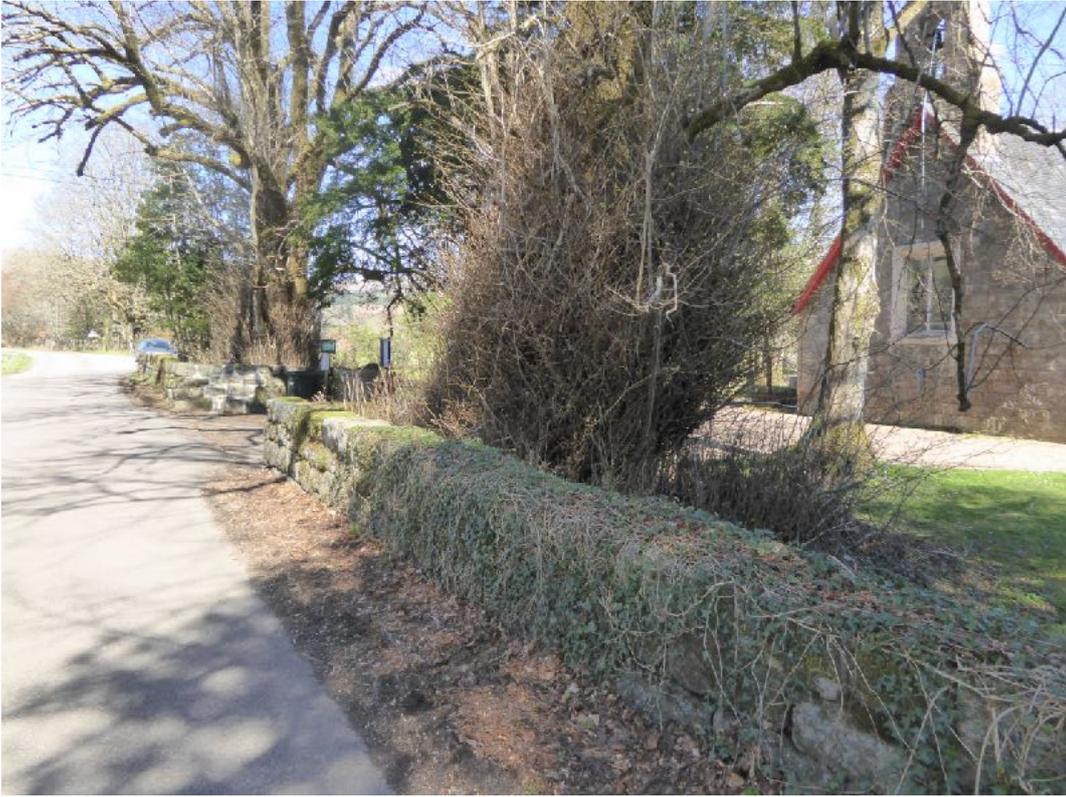
There is a stone boundary wall on the main road side and post and wire fencing elsewhere. The stone wall requires minor repair. The fence is in poor condition.

*Stone wall at road frontage*

Repair boundary wall
